Evaluation of industrial workplaces with ViveLab

Mária Babicsné Horváth
bhorvathmaria@erg.bme.hu

Case studies

Corrective methodology

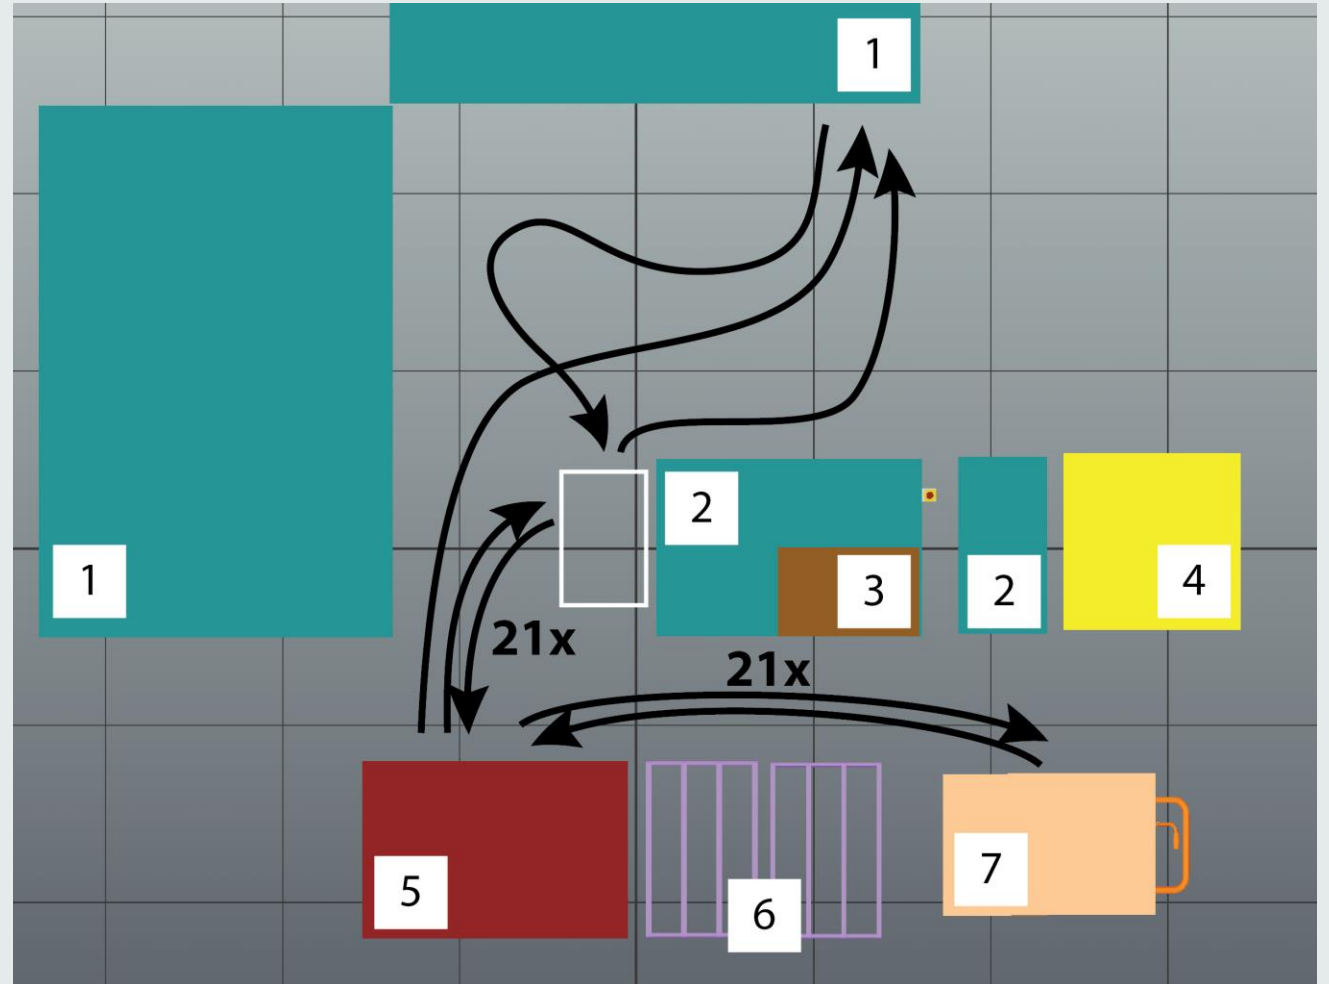
Post-heat treatment

- Length of work cycle: 9 minutes
- In less than 3 minutes 21 times smaller routes are made back and forth

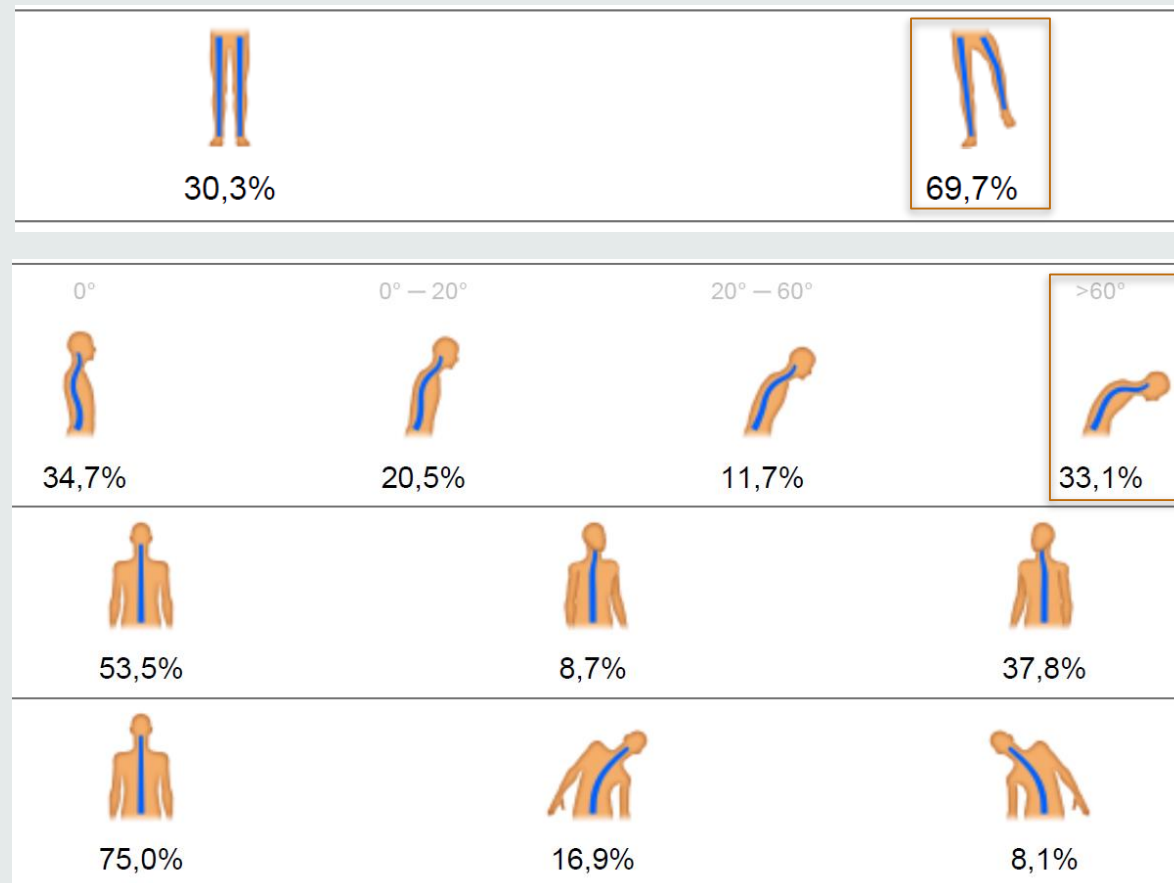
Analysis in Vivelab

- ISO 11226
 - **Torso bent position**
 - Elevated position of arms
 - Head forward bending
- EN 1005-4
 - **Torso bends**
 - Arm elevations
 - Knee bends
- RULA
 - Leg loading
 - Wrist, elbows, shoulders
 - **Torso stress**

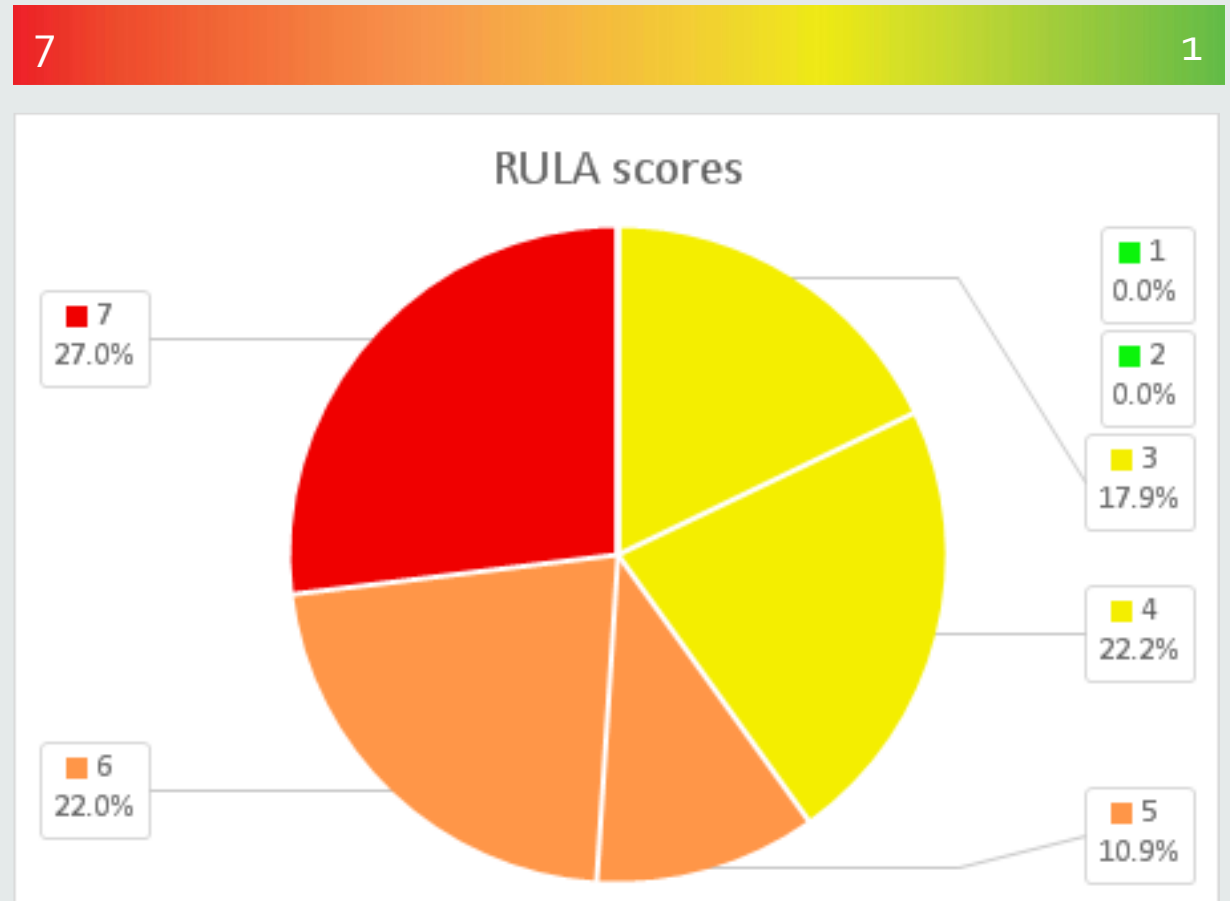
Analysis in Vivelab

- RULA

27% - 7

Immediate change is required

32.9% to 5.6

Changes are required as soon as possible

40.1% to 3.4

Further investigation
